# Gear Test Assembly – Report of Experimental Testing – FY2020

E. Kent, H. Belch, C. Grandy, D. Kultgen, M. Weathered

Nuclear Science and Engineering Division, Argonne National Laboratory

September 2020

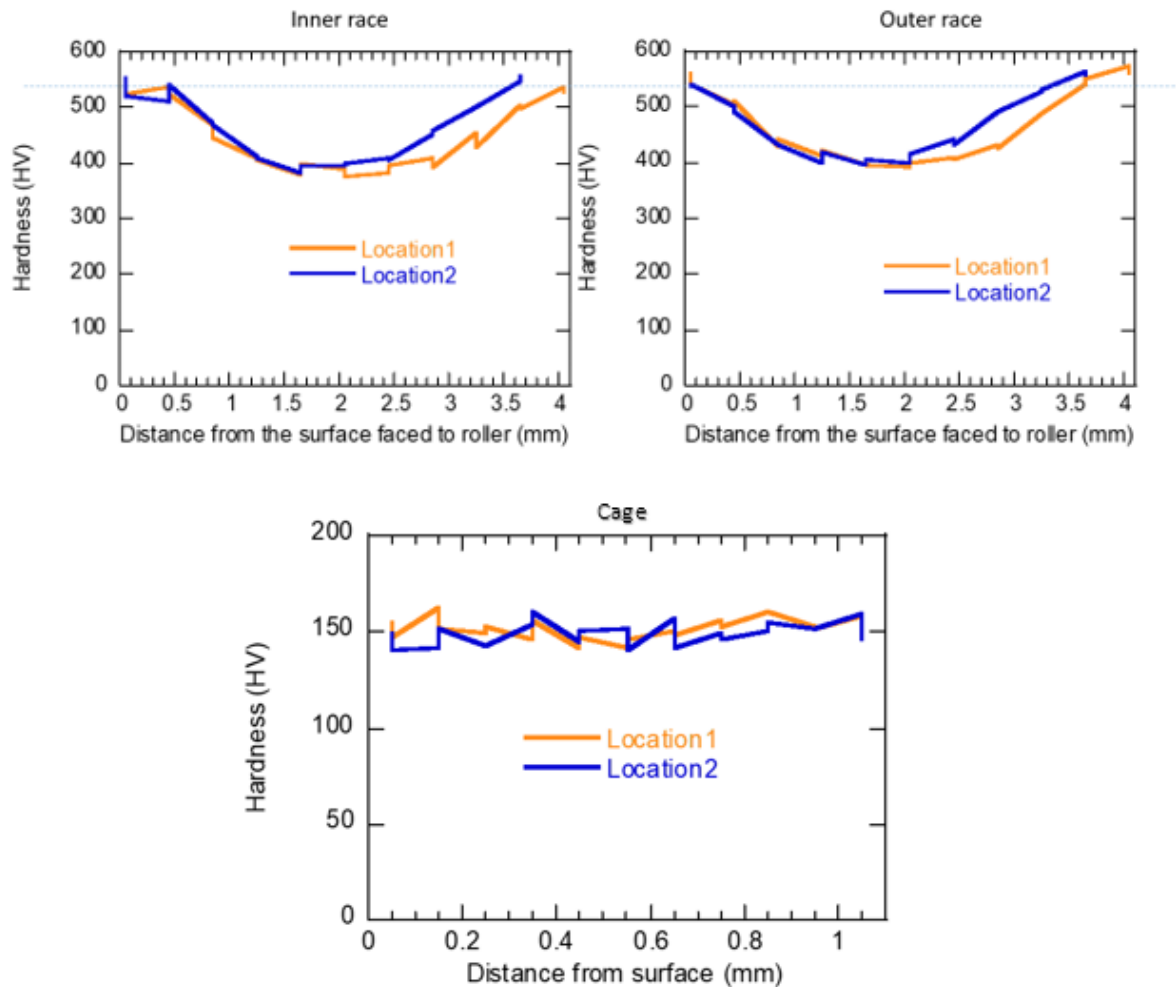
After removing the GTA from Test Vessel 1 and cleaning the residual sodium, the GTA was disassembled. It was discovered that one of the sodium bearings had a failure, leading to the system seizing up. The sodium bearings used in this campaign were Timken brand tapered roller bearings fabricated out of 52100 bearing steel and heat treated to allow for operation up to 350°C. Post operation micro-hardness testing of the bearing components (Figure 5) revealed the cage material was not 52100 steel, but likely a lower grade carbon steel. Figure 6 and Figure 7 show the condition of the failed bearing during and after removal and cleaning. The physical condition of the bearings, along with the micro-hardness data, suggest the failure occurred at the cage.

Figure 5: Micro-hardness testing of cross-sections of the inner race (left), outer race (right), and cage (bottom).

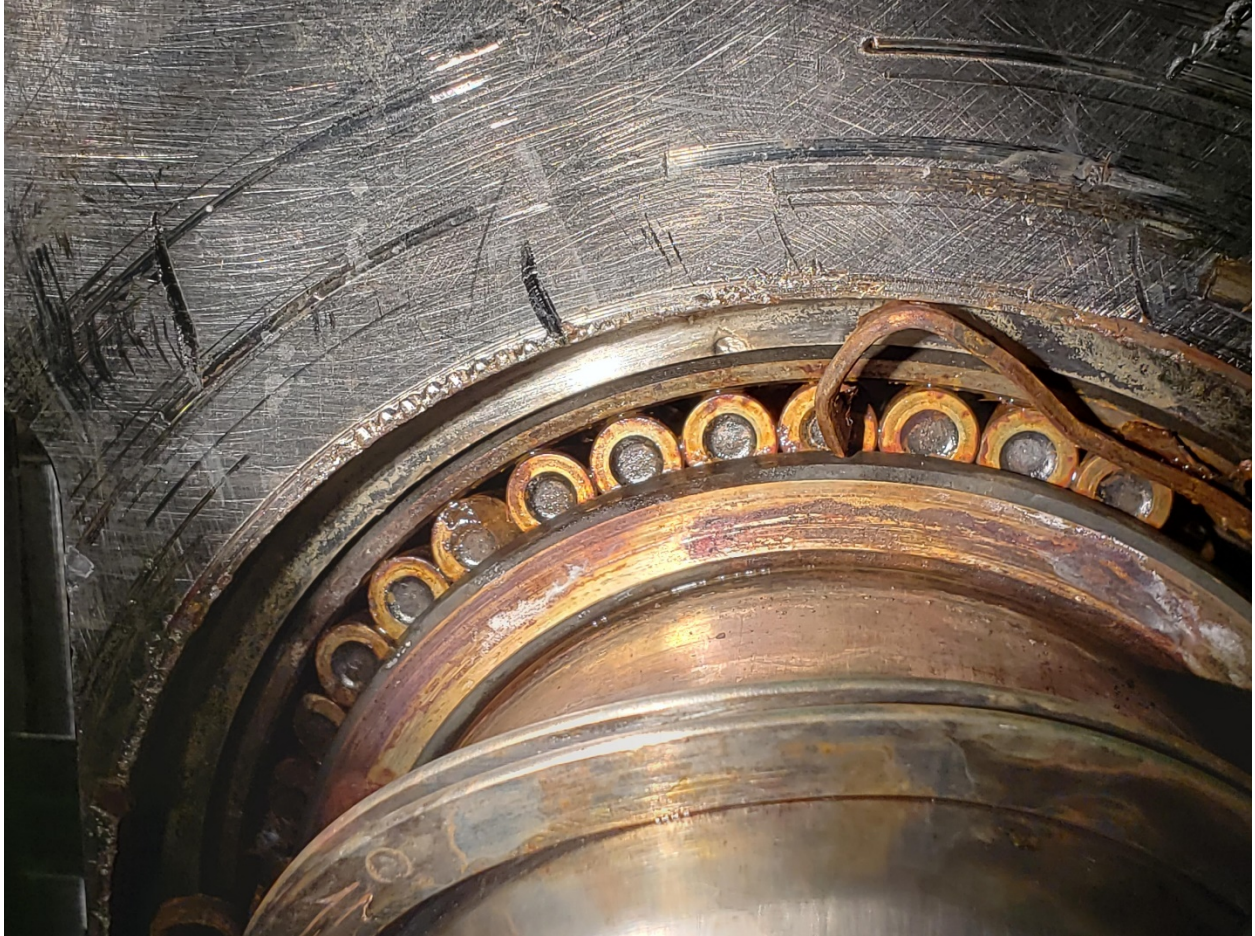
**Figure 6: Condition of failed bearing found during disassembly. Note that the rust on the bearings was a result of the water bath used during disassembly.**

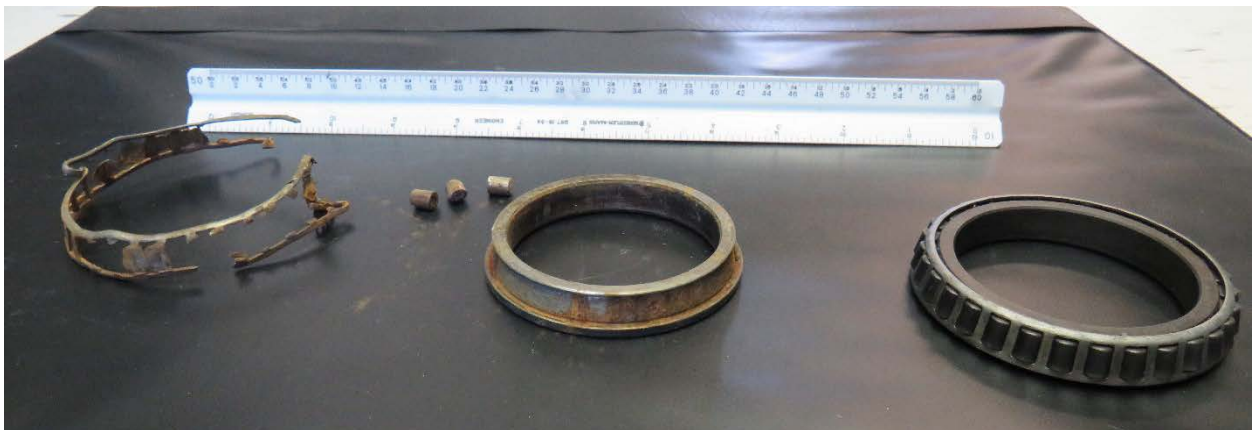
**Figure 7: Image of failed bearing cage (left), failed bearing inner race w/ rollers (center), and an untested bearing.**

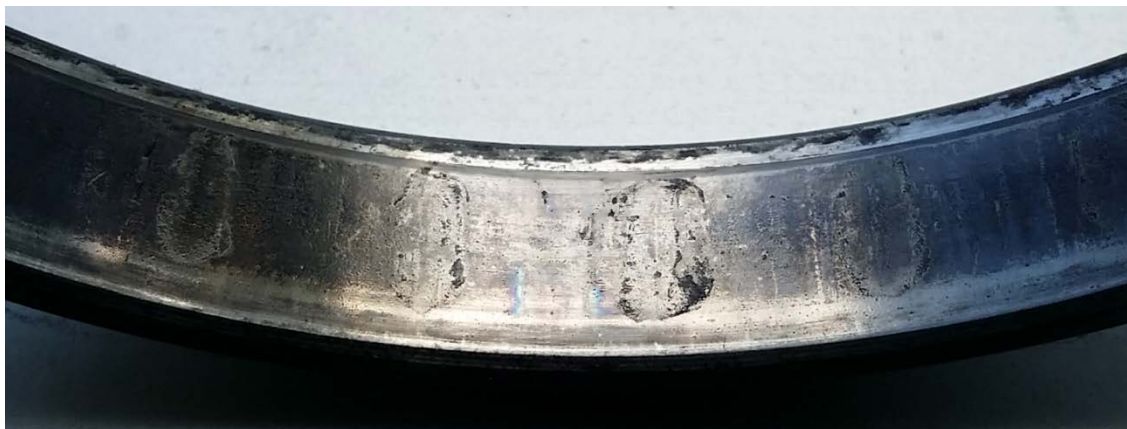
During the first campaign, there were several failures of the bearings in the external gearboxes that connect the drive motors to the drive shaft (Figure 8 & Figure 9). This gearbox was originally

designed as an open gearbox due to concerns of over packing the gearboxes with grease, potentially leading to a failure. This reduction in lubrication, along with the possibility that the gearboxes were excessively preloading the bearings, led to multiple external bearing failures. This required a temporary shutdown of the GTA, disassembly of the external gearboxes, and replacement of the failed bearings.

**Figure 8: Image of failed external gearbox bearing showing wear and deformation caused by lack of lubrication and excessive bearing preload.**

The bearings in the external gearbox that mate the motors to the drive shafts failed multiple times during Campaign #1. The lack of lubrication and excessive preload of the bearings likely lead to their early failure. To address the lack of lubrication, a seal plate and grease port were added to the external gearbox assembly. The seal plate helped to close the bottom of the gearbox, preventing grease from escaping the system. The grease port allowed for additional grease to be added to the gearbox as the system operated. Figure 20 shows the external gearbox with the modifications, and Figure 21 is a cutaway of the gearbox to show how the seal plate helps to close the bottom of the gearbox. Additionally, shims were added during assembly to prevent excessive bearing preload. These modifications were implemented during the final stages of Campaign #1, and we're kept for Campaign #2. No additional external bearings failures have been experienced.

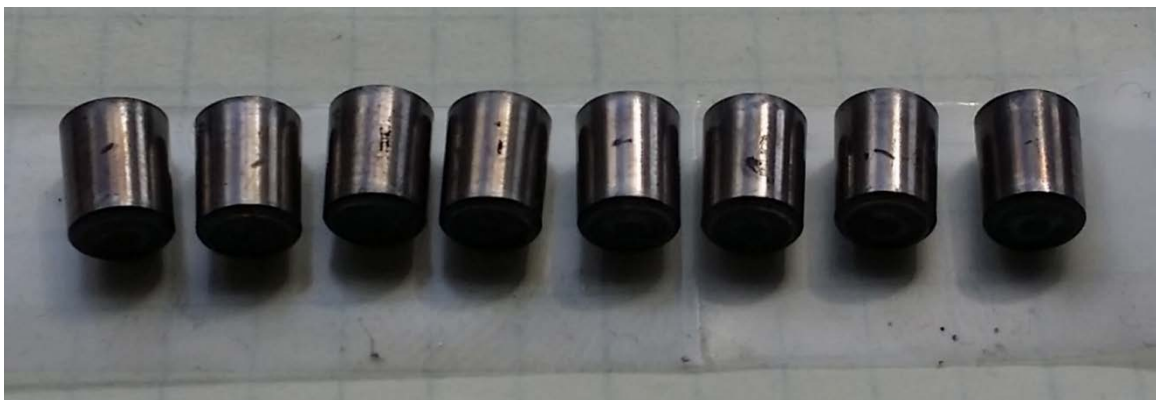
**Figure 9: Image of damaged rollers taken from failed external gearbox bearing.**

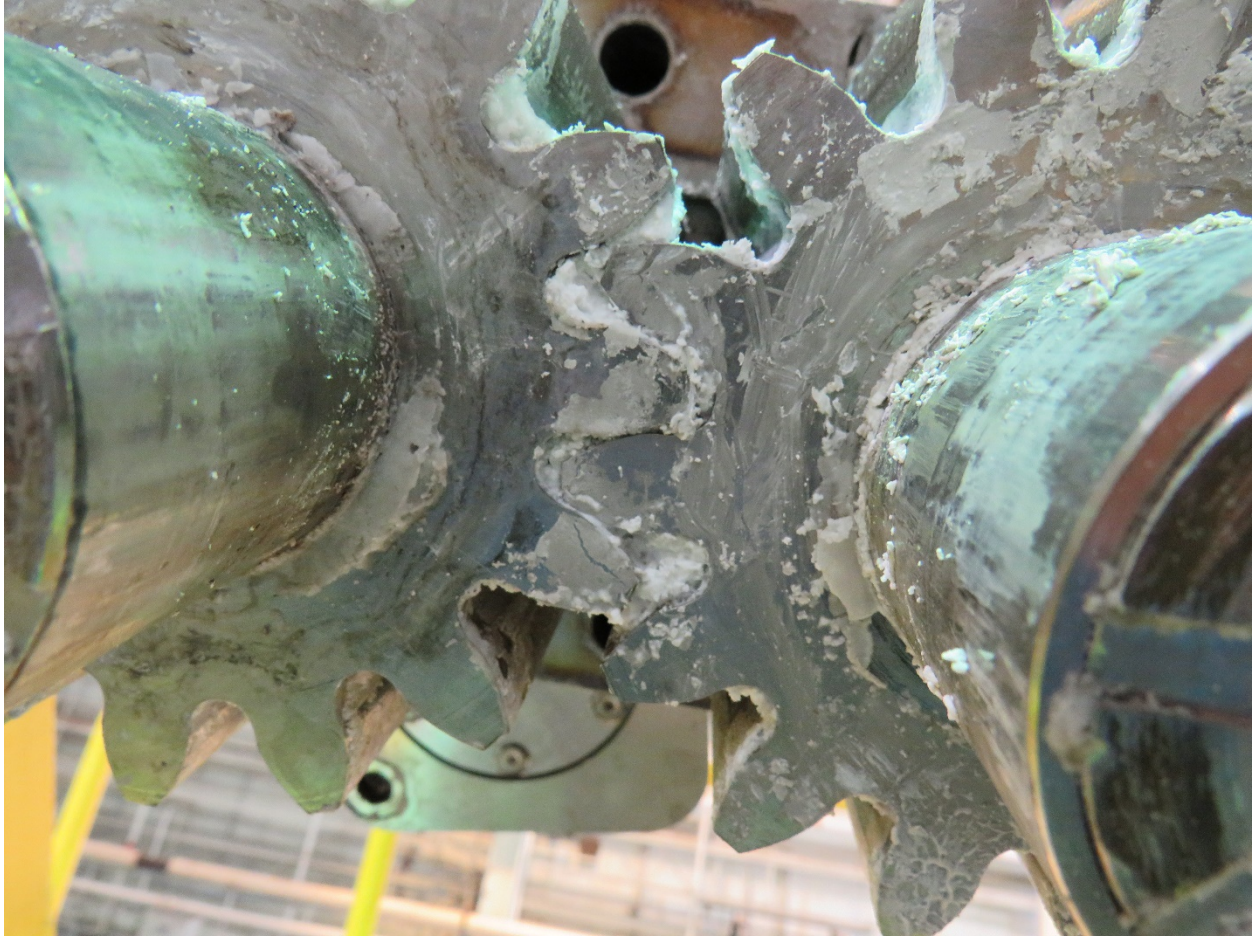
While the Carbonation System was able to react most of the residual sodium away, the process led to some difficulties during disassembly. As the sodium reacts to produce sodium bicarbonate, the product expands in volume roughly by a factor of five [2]. This was problematic in places where there wasn't room for the sodium bicarbonate to expand, most notably the thin clearance gap between the gears and the shaft (Figure 13). The expansion of sodium bicarbonate between the gears and shafts tightly bound the gears to their respective shaft.

**Figure 13: Image showing sodium bicarbonate "caked" between the gears and the shafts.**

To proceed, it was decided that the sodium bicarbonate needed to be dissolved into solution to effectively free the gears. An alcohol bath was used first to react away any pockets of sodium that may have remained hidden. Next, a water bath was used to dissolve the sodium bicarbonate. Both baths used an ultrasonic cleaner with heater (Figure 14) to more effectively clean the components. Following these baths, the gears were readily removed.

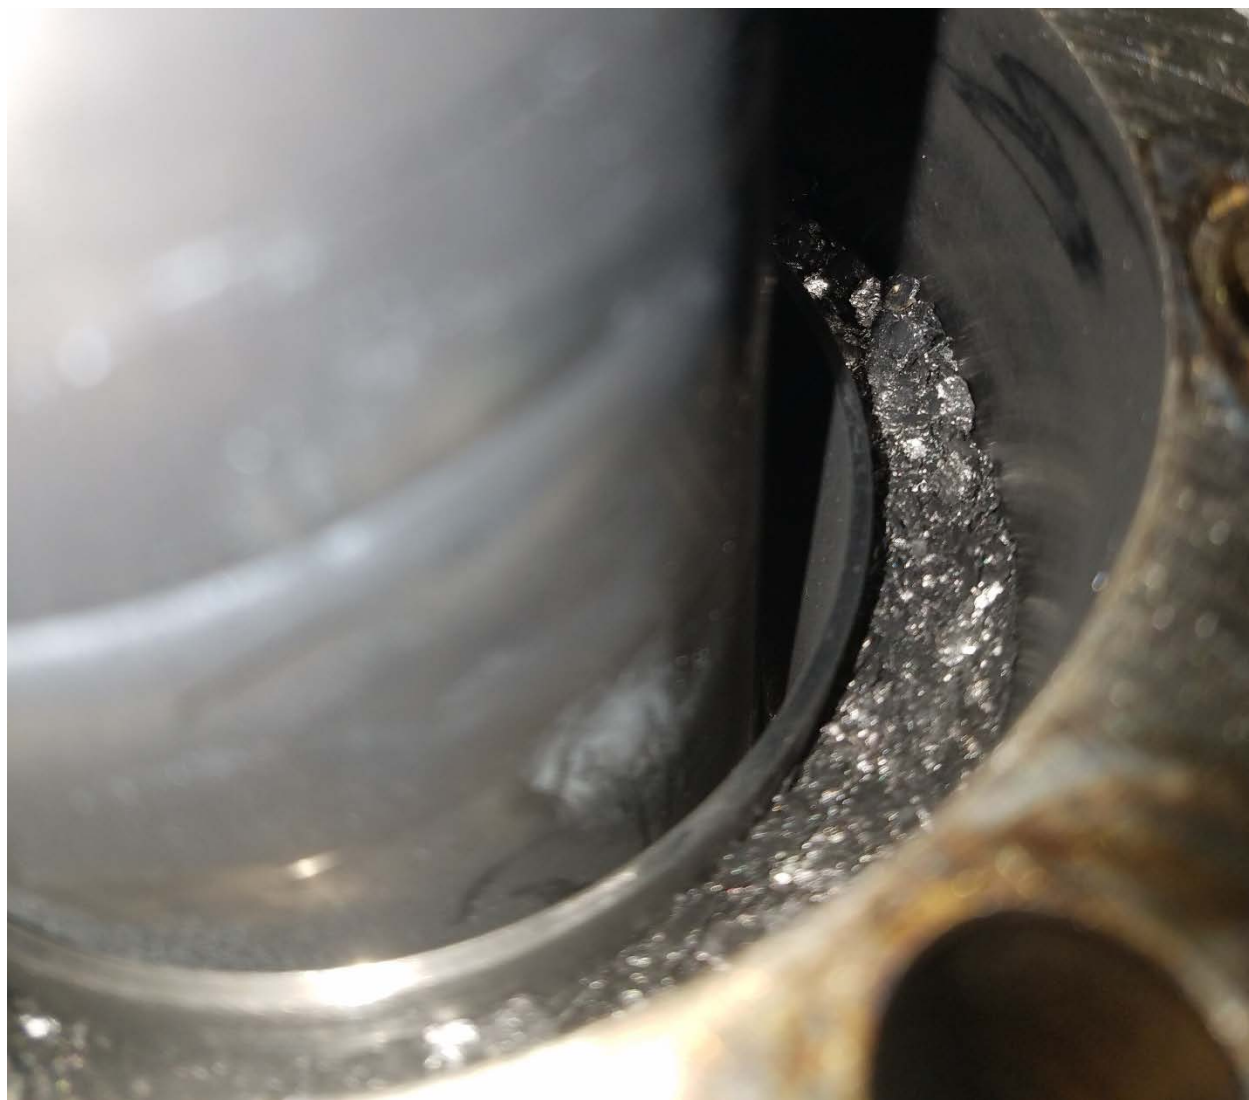
The seal system included a graphite catch below the flange inside the gas space of the GTA. During disassembly, a significant amount of graphite was found in the catches. The catches were designed to hold  $>7\times$  the volume of the graphite rings, but fragmentation of the seal led to an increase in volume. As seen in Figure 16, the graphite reached the top of the lip and likely had some spill over into the test vessel. While a small addition of carbon to the sodium inventory is not a major concern, this issue needed to be addressed.

**Figure 16: Graphite flakes filling graphite catch.**

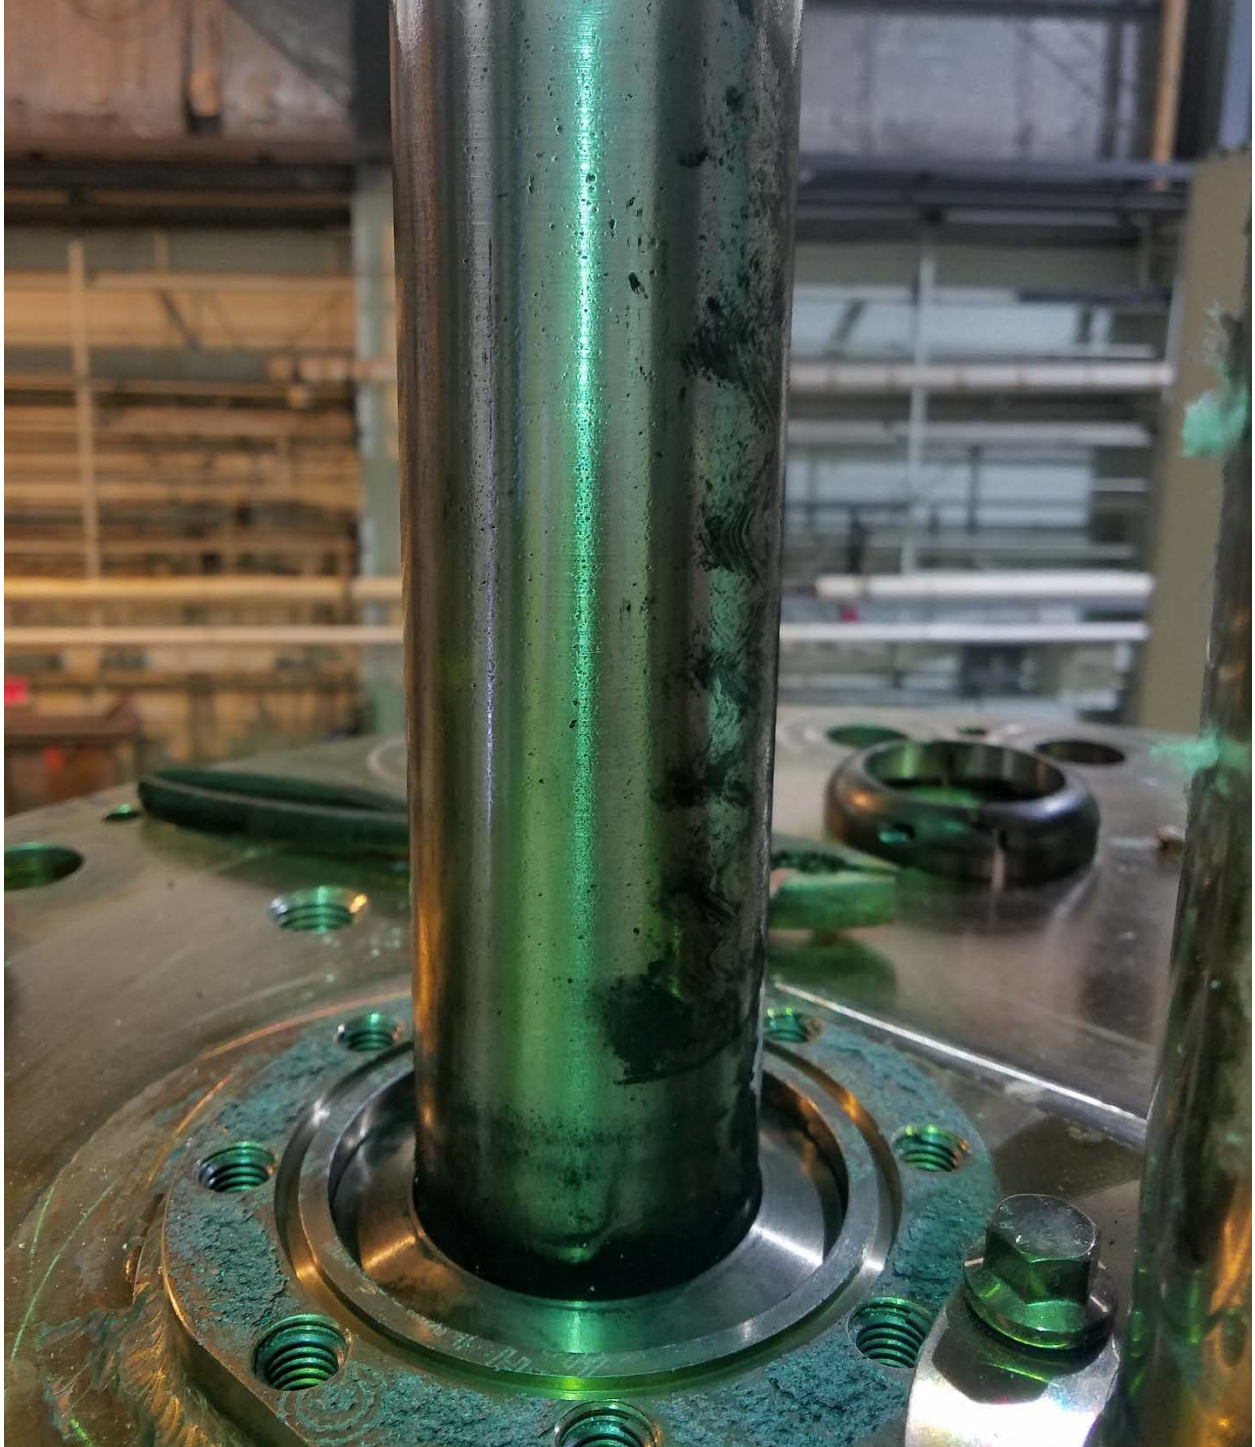
An additional issue with the original seal design was the required use of silicone O-ring lube for the top seals. This lube eventually made its way past the O-ring seals and travelled down the shaft. While silicone is compatible with sodium, this is a potential contamination route. Figure 17 shows the condition of the shafts during disassembly. Silicone lube is visible on the shaft, particularly where residual graphite has stuck to the lube.

**Figure 17: Image of the drive shaft during disassembly. Note the coating of clear silicone lube on the shaft, as well as graphite residue that has stuck to the lube.**

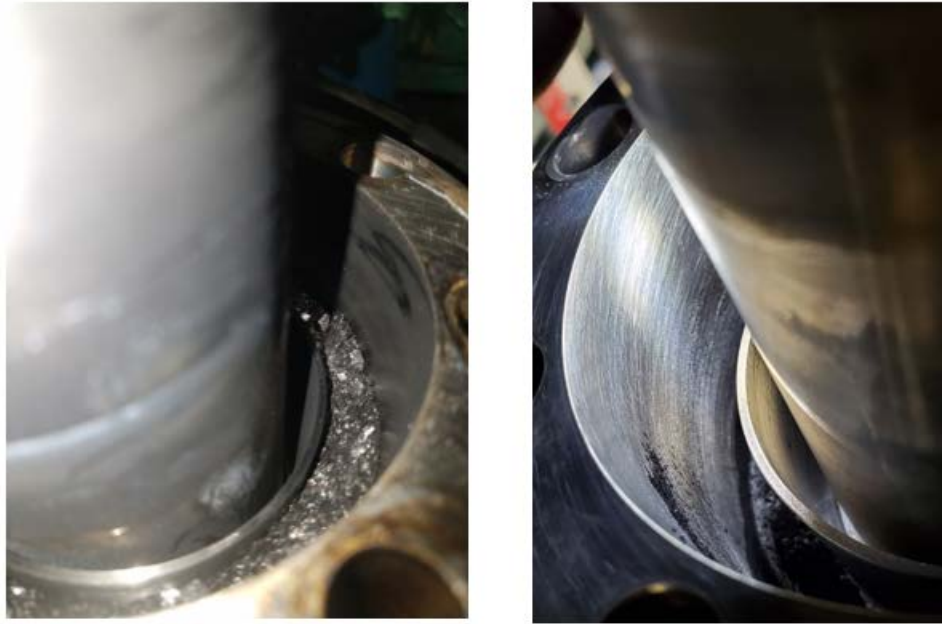
Inspection of the graphite catch during the second campaign disassembly process found a significant reduction in graphite debris. While the second campaign only operated roughly 10%

the duration of the second campaign, the reduction in graphite debris suggest the new shaft seal design performs more effectively.

**Figure 19: Significant reduction in graphite debris using new seals.**

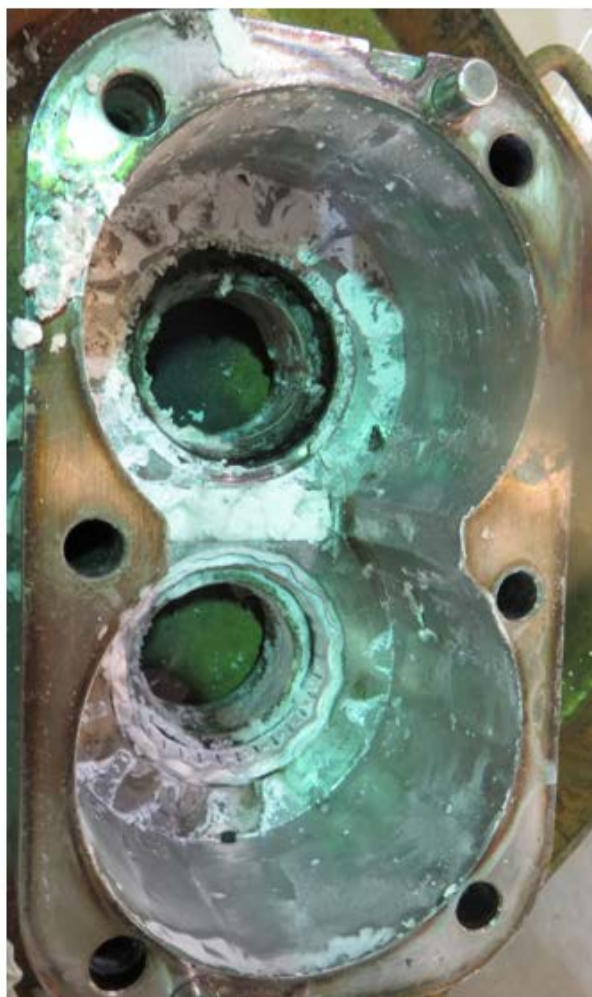
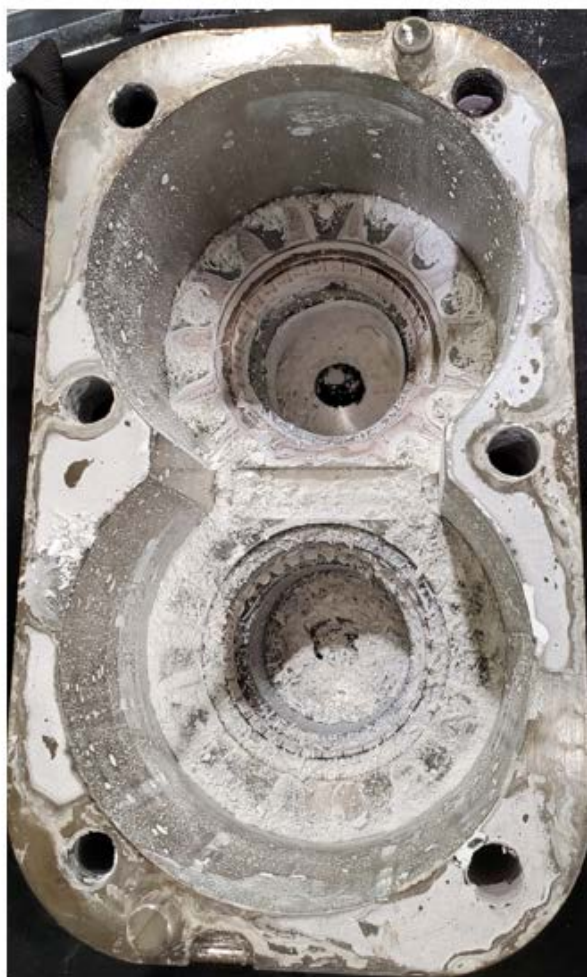
The sodium gearboxes were designed with 0.250" holes to allow for sodium to drain out, but a considerable amount of unreacted sodium remained in the gearboxes following carbonation in Campaign #1. This was likely due to the holes plugging with sodium bicarbonate during the carbonation process, not due to sodium flow issues during the vessel drain. These holes were increased to a 0.500" diameter for Campaign #2 to allow for better drainage and carbonation penetration. The addition of reaction vessel heaters and bigger drain holes led to a more effective carbonation process. Figure 30 compares the reaction products that remained in the larger of the sodium gearboxes following the carbonation process. Campaign #1 had considerable amounts of unreacted sodium left in the gearboxes, most noticeably where the bearings were located (Figure 31). The modifications made for Campaign #2 greatly improved the extent of the carbonation. This is demonstrated by observing more white and flaky debris in the right image of Figure 30 and Figure 31.

**Figure 30: Remaining reaction products following carbonation from campaign 1 (left) and campaign 2 (right). Drain holes added to gearbox, plus modifications to carbonation system significantly improve carbonation penetration.**

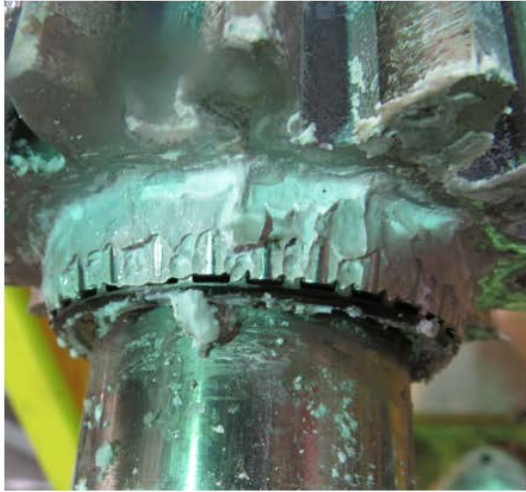
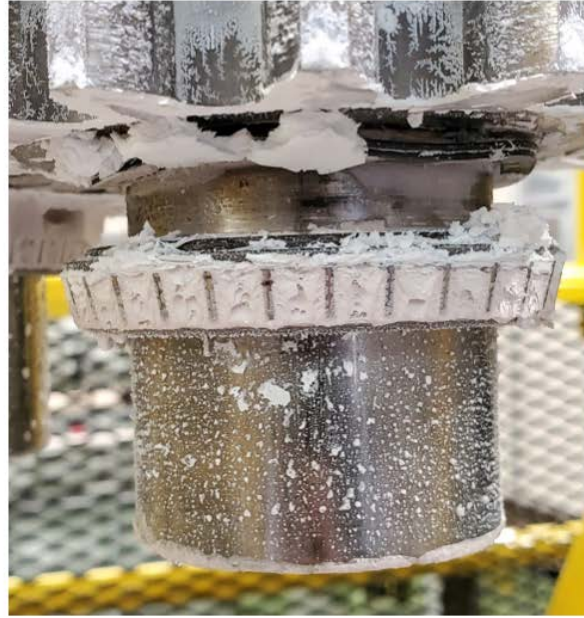
**Figure 31: Comparison of remaining sodium on bearings following carbonation process.**

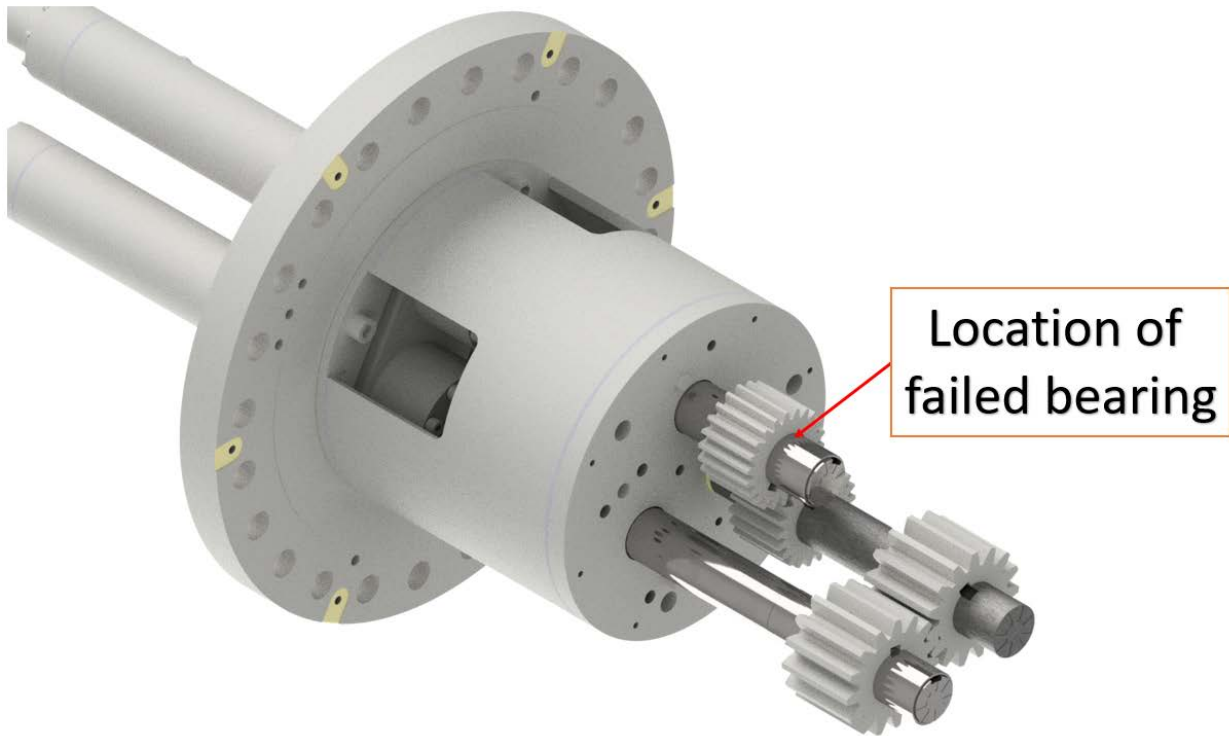
Following the cleaning process, the GTA was fully disassembled to determine the source of the vibration. A bearing was found to have failed on the short drive shaft, below the small test gear. Figure 32 indicated the location of the failed bearing on the GTA. The bearing failed completely

**Figure 32: Partially disassembled view of GTA with location of failed bearing called out.**

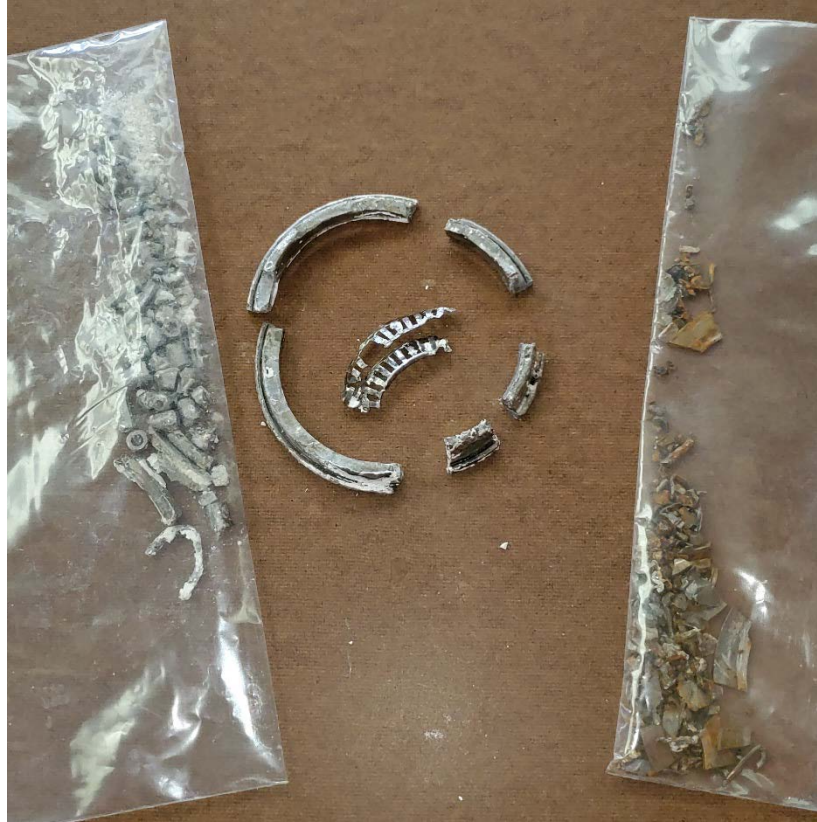
with the cage, races, and rollers fragmenting into small pieces of debris. Figure 33 shows what remains of the bearing was found in the gearbox and in the fine catch screen. The catch screen was found to be in good condition, suggesting no bearing debris made it into METL.

**Figure 33: Remains of complete bearing failure.**

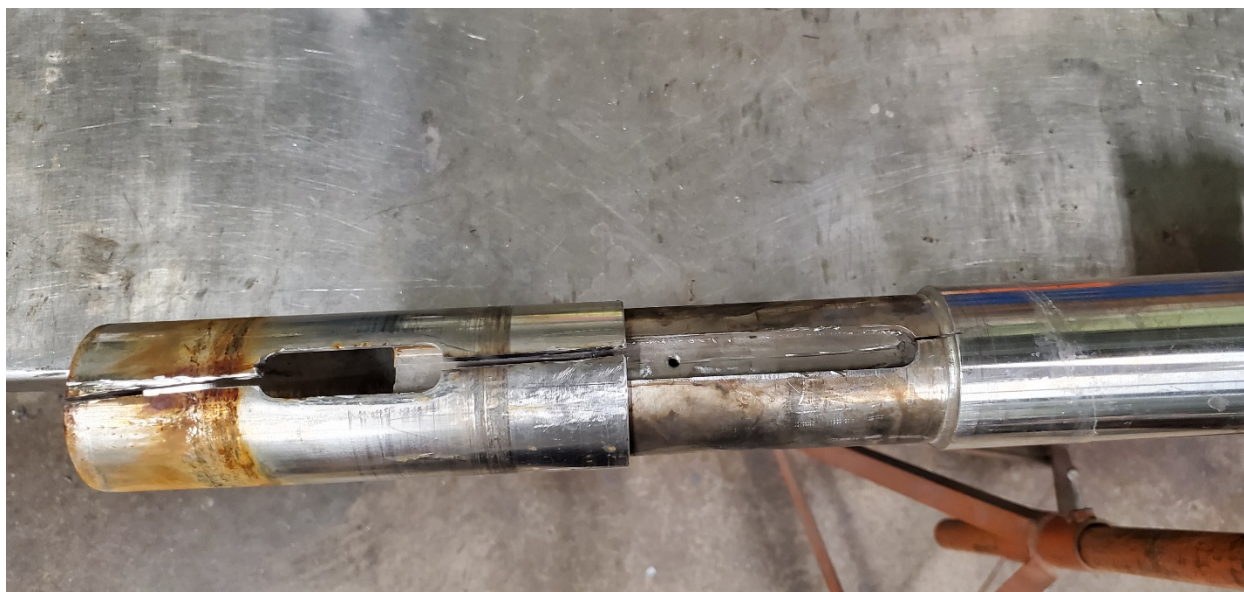
The remains of the bearing failure damaged the shaft sleeve where the gears and bearings are mounted. Various attempts to remove the shaft sleeve while keeping it in a usable condition were unsuccessful, so the shaft sleeve was cut to allow for removal. Figure 34 shows the condition of the shaft sleeve following cutting. The orange and brown discoloration at the bottom of the sleeve indicate the area damaged by the failed bearing. New shaft sleeves are being manufactured to replace the damaged one. Once the new shaft sleeves are fabricated, the GTA will be reassembled for continued testing in the METL facility in FY21.

**Figure 34: Shaft sleeve that required cutting for removal. Discoloration at end of sleeve caused by failed bearing.**
